This is a translated excerpt from the report “RESULTATER OG ERFARINGER FRA ENERGIRENOVERING AF RYESGADE 30”, JULY 2014 describing only the three new ventilation systems in Ryesgade 30.

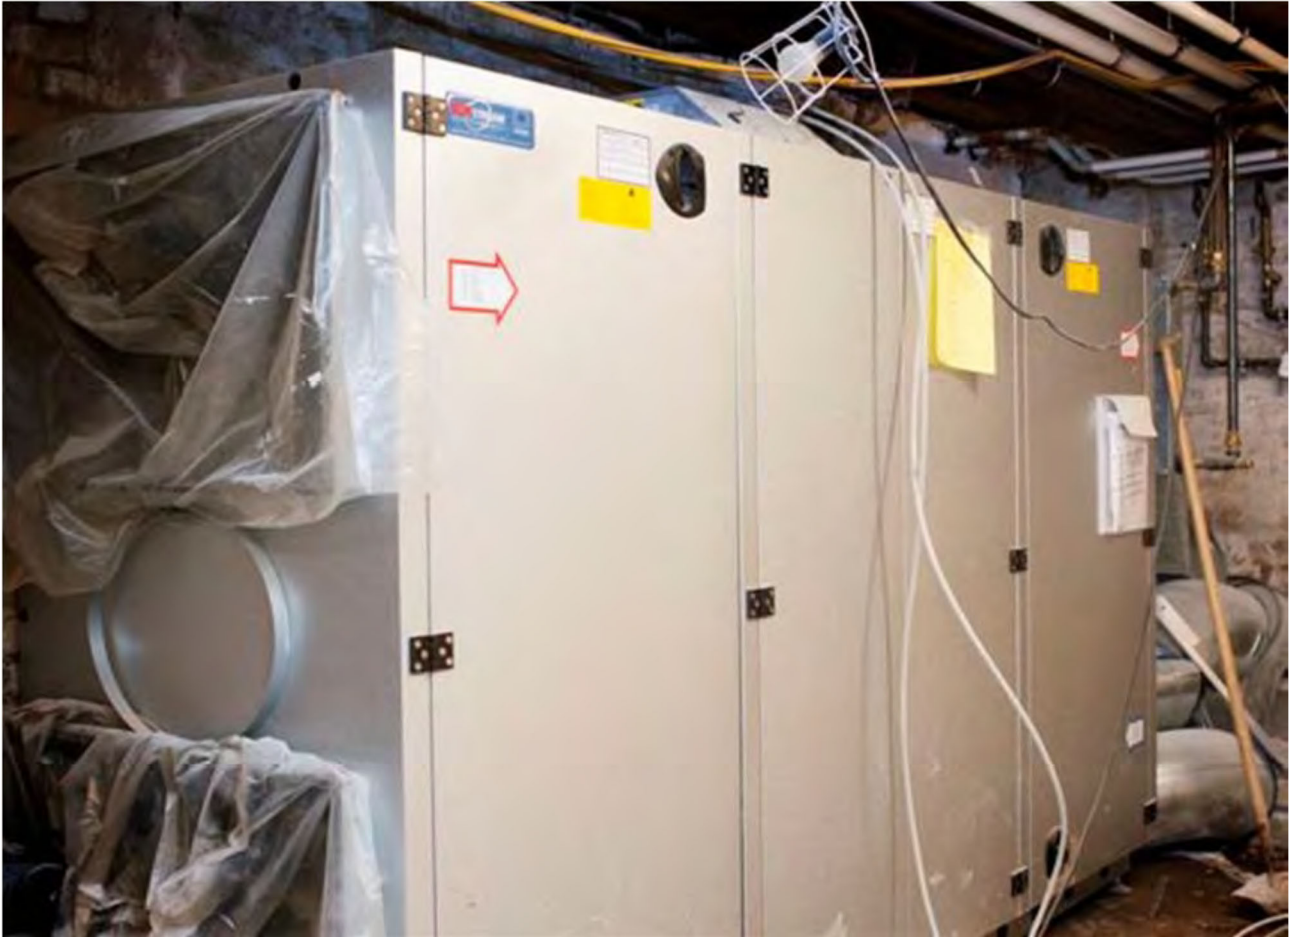
A traditional central mechanical ventilation system is located in the basement.

Fig. 1. Traditional central ventilation system.

The unit has fresh air intake at basement level by staircase. Existing chimneys are used to conduct air from the exhaust ducts from bathrooms and kitchens to the basement. In addition, existing chimneys are used to return used air over roofs. Fresh air is diverted to apartments via new ducts (feeding of fresh air via existing chimneys was considered but would necessitate a relatively expensive and complicated ductwork without guaranteeing a sufficiently low pressure loss and it would be difficult to integrate silencer in each room of the dwelling).

The plant is fire-resistant in the form of a smoke-ventilated system with smoke fan located on the roof.

The air supplied to the remaining rooms has a constant air flow of 140 m³/h. The exhaust air from the bathrooms is constant at 20 m³/h when the relative humidity is below 55% and 54 m³/h when it exceeds 55%. In the kitchen, the suction is generally 72 m³/h, but increases to 144 m³/h when the hood is activated. The plant in stairwell A has a significantly higher electricity consumption than the corresponding central

plant in stairwell B. This is partly due to the large use of existing chimneys, which results in relatively large pressure losses.

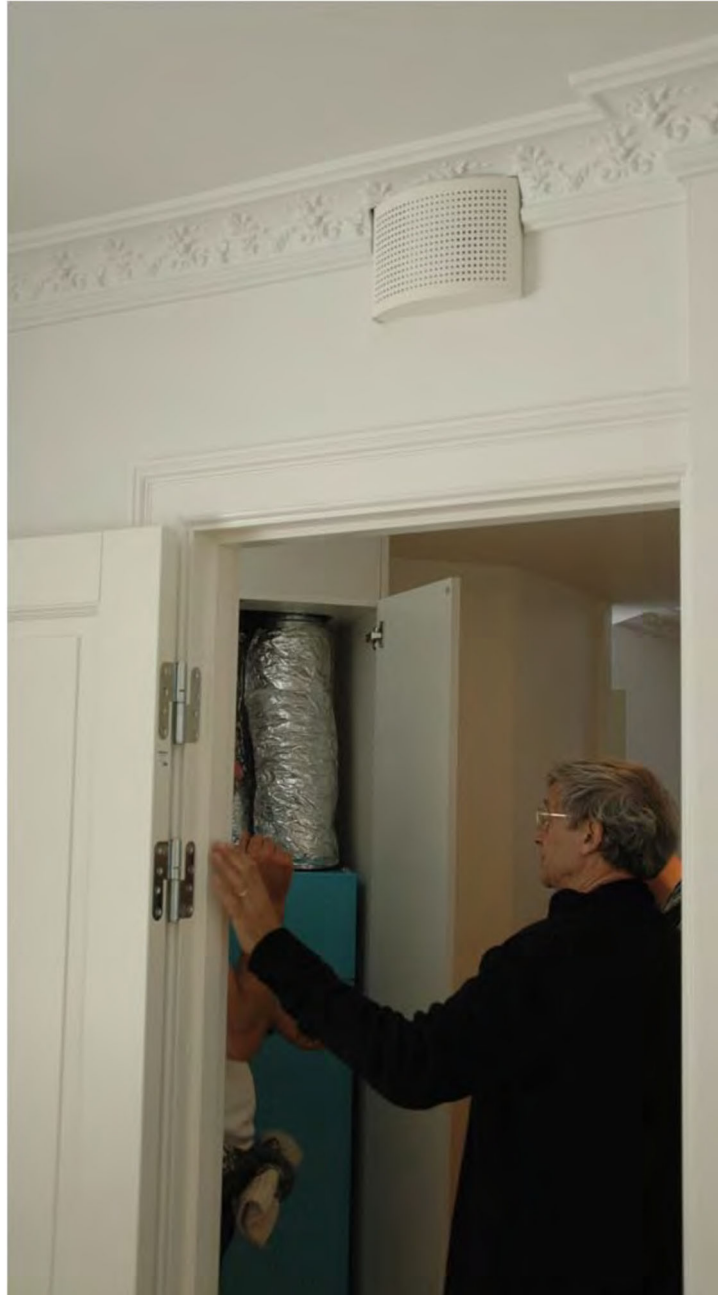
The ventilation systems in entrance C are decentralized systems at the apartment level. This means that each apartment has its own unit.

Fig. 2. Decentral ventilation system in a kitchen closet.

The units are wall-hung and placed in cupboards in the kitchen and hallway.

Each plant has fresh air intake via the facade. On one side of the stairwell, returns are managed over roof for each plant via fire insulated ducts in duct shaft. On the other side gable wall return without windows. The ventilation systems are running without any kind of need management. However, the system can be forced to maximum capacity by enabling scope. The system is not equipped with intelligent dampers for priority of suction from exhaust during forced operation. Then the plant has a capacity limited to approx. $180 \text{ m}^3/\text{h}$, then the efficiency of the range is I several of the apartments are relatively limited due to inadequate suction (this can be improved using intelligent dampers).
